STEEL POLE REPAIR & REJUVENATION

INDUSTRY	Electrical Transmission Utilities
CLIENT	Powercor
DISTRIBUTOR	Shield Crete Services Australia www.shieldcreteinternational.com.au
APPLICATOR	Powercor
PROJECT	Surface prep, welding on a compensation plate for strength restoration, application of ShieldPoly Polekote.
LOCATION	Various Locations, Victoria, Australia
SYSTEM	Surface prep and application of ShieldPoly Polekote to a minimum 0.7mm thick.
DATE	May 2018 - ongoing

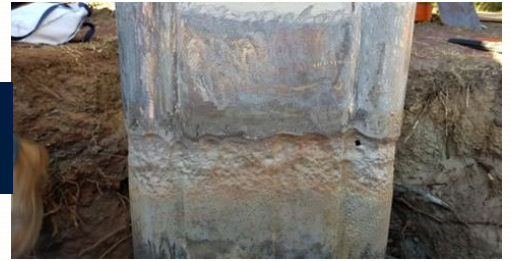
GL Corrosion after less than 30 years average 6mm+ wall loss with some pits holed through.

Regular inspections by Powercor identified heavy corrosion around the ground line of the manufactured steel pole; 12.7mm plates between 9mm thick 100mm diameter pipe. CoEng.biz was engaged to assess the remaining strength, inspect the poles to the base plate connection some 1m below ground level, and prepare remediation recommendations.

It was assessed that approximately half the original strength remained. The pole is in a built-up area of South Yarra on the outskirts of Melbourne and supports an Underground to Overhead (UGOH) oil-filled cable. It would cost in the order of \$3M to change the pole out. Hence, the decision was made to remove the corrosion, weld a steel strengthening plate over the corroded area, and re-coat the entire steel surface below ground and up to 200mm above ground.

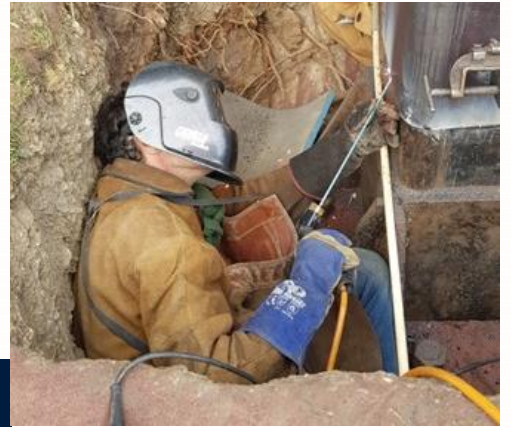
Welding the strengthening on.
