REPLACE DAMAGED COLD STORAGE FLOORING

INDUSTRY	Mining
CLIENT	Dugal River Mine
DISTRIBUTOR	ShieldCrete Australia 1800 364 776 www.shieldcreteinternational.com
APPLICATOR	Spillers QCC
PROJECT	Replace damaged linoleum flooring and provide easy-clean non-slip floor.
LOCATION	QLD, Australia
COATING SYSTEM	2mm ShieldPoly F-15 over ShieldPrime UNI primer.
DATE	2018

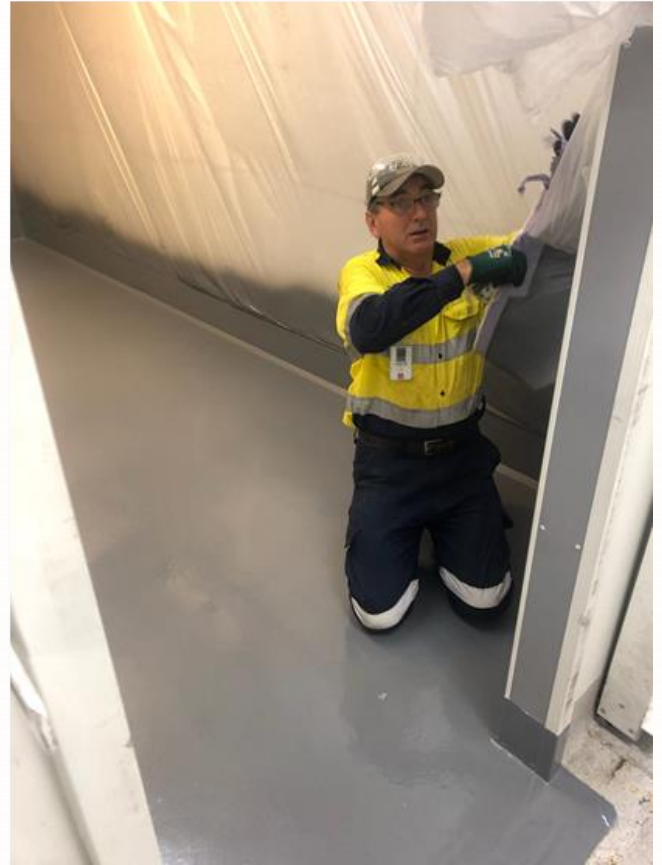
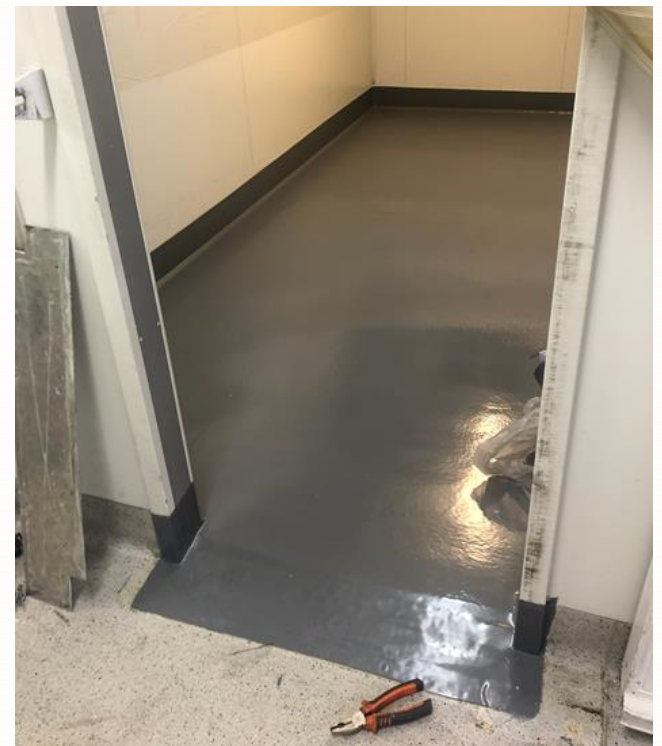
The client's freezer floor was constantly being damaged from the regular movement and cleaning, particularly at the door. They contacted Spillers QCC who suggested Polyurea as the most appropriate solution.

Once on site and the flooring was exposed, it was noted that there was significant water/ice damage to the floor panels. The panels were replaced, and the coating applied.

The coating was finished with a dry-fall application technique to give slip resistance and ease of cleaning.

Against all advice, the customer used a moisture absorbing floor material for the repairs. Despite the decision, they have had years of good service from the polyurea as it is unaffected by the cold temperatures and the traffic.
