POLYUREA COATING OF CIL TANKS

INDUSTRY	Mining
CLIENT	Alkane Resources – Tomingley Gold
DISTRIBUTOR	ShieldCrete Australia 1800 364 776 www.shieldcreteinternational.com
APPLICATOR	Protector Coatings
PROJECT	Corrosion, chemical resistance, and abrasion protection of processing assets.
LOCATION	NSW, Australia
COATING SYSTEM	3-4mm ShieldPoly F-15 on walls and 4mm on floor.
DATE	2015/16

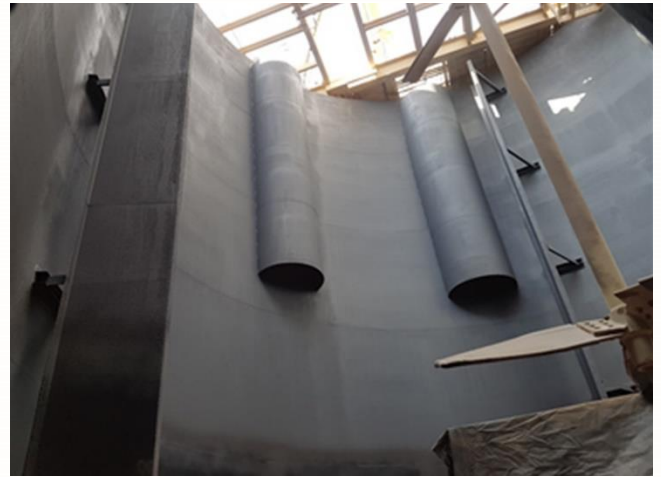
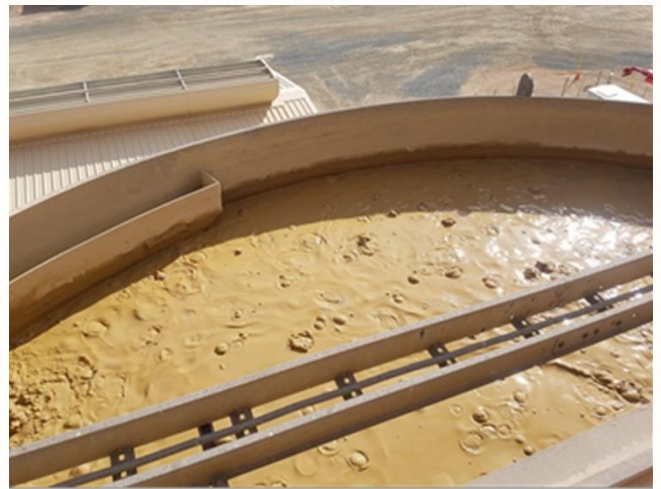
Less than 2 years into their service life, the CIL tanks at Tomingley Gold were inspected and found to be heavily eroded in addition to considerable pitting. To arrest the corrosion and erosion, Tomingley decided to coat the tanks in ShieldPoly F-15.

Polyurea coatings are ideal for protecting these assets because they are extremely abrasion resistant, highly chemical and corrosion resistant, and they perform exceptionally under constant immersion. The best thing about polyurea is that it handles large walls and intricate details around baffles equally well, and it is extremely abrasion resistant.

The tanks were coated one at a time, keeping 5/6 tanks online at any one time. Including cleaning it took around 7 days for each tank to be returned to service.

In this case, an etch primer was used due to the staging requirements and open times that were required. It is this flexibility in our systems that mean we get the best result possible for the project specific constraints.
